ELVITA

Service Bulletin

Product category:	Tumbledryer
Affected models:	CTT7800V, CTT7100V
Release:	1.0, 2023-04-03

Compressor terminals falls off

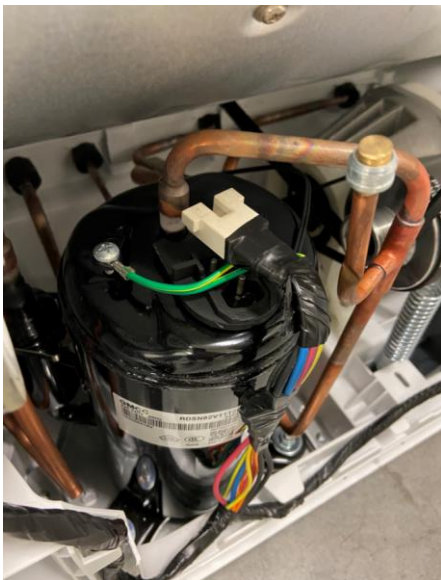
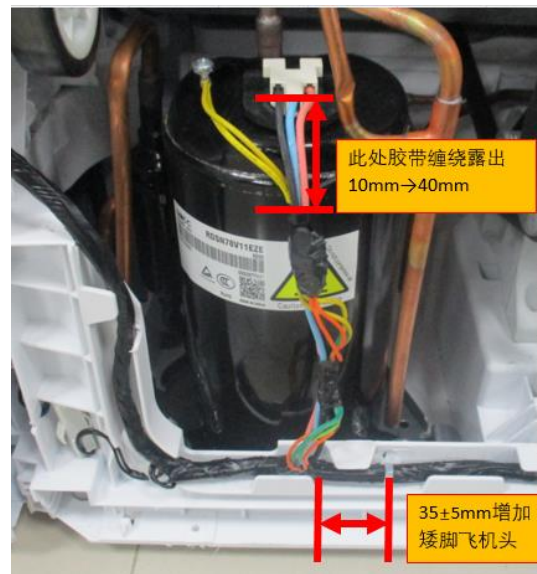
Due to too stretched cables in harness up to the compressor terminal there has been cases where the compressor terminal comes loose caused by vibrations from transporting the product and when the machine is running. The most common error description from the customer is poor/no drying.

Remove black tape from the terminal and 40 mm down on the harness.

Pull harness at the bottom to the right about 35 mm and fix it with a new cable tie.

Important! Make sure no electrical cables are in contact with or at risk to any refrigerant pipes. Risk of fire!
