Built-in MWO-H20L Control Panel and Door Panel Engineering Update

1. Update background

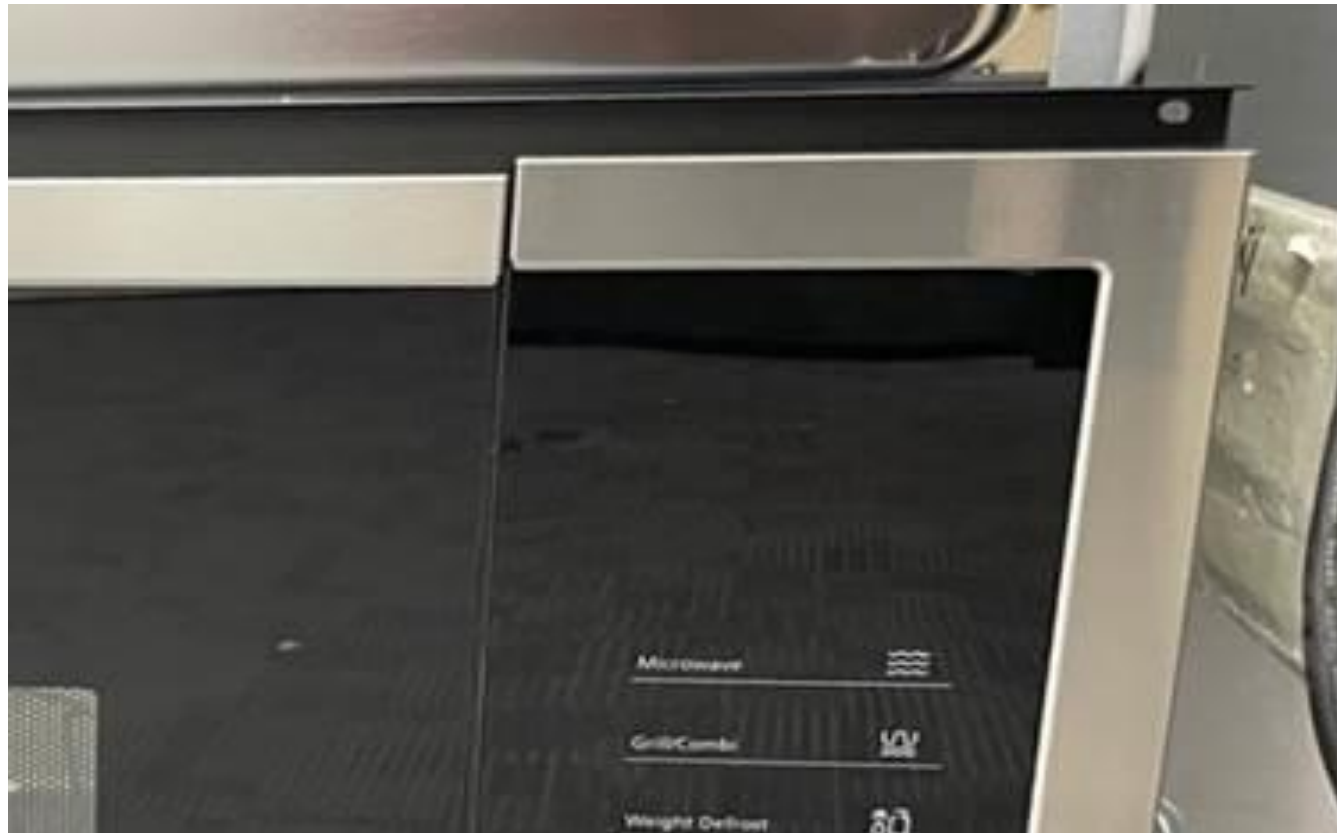
Regarding the customer complaints on markets, for the built-in microwave oven, there was issue of height inconsistency (see below picture), which has caused many after-sales cases for our customer, therefore, our engineer team developed the adjustment plan for this issue, The main changes locates in control panel and door panel.

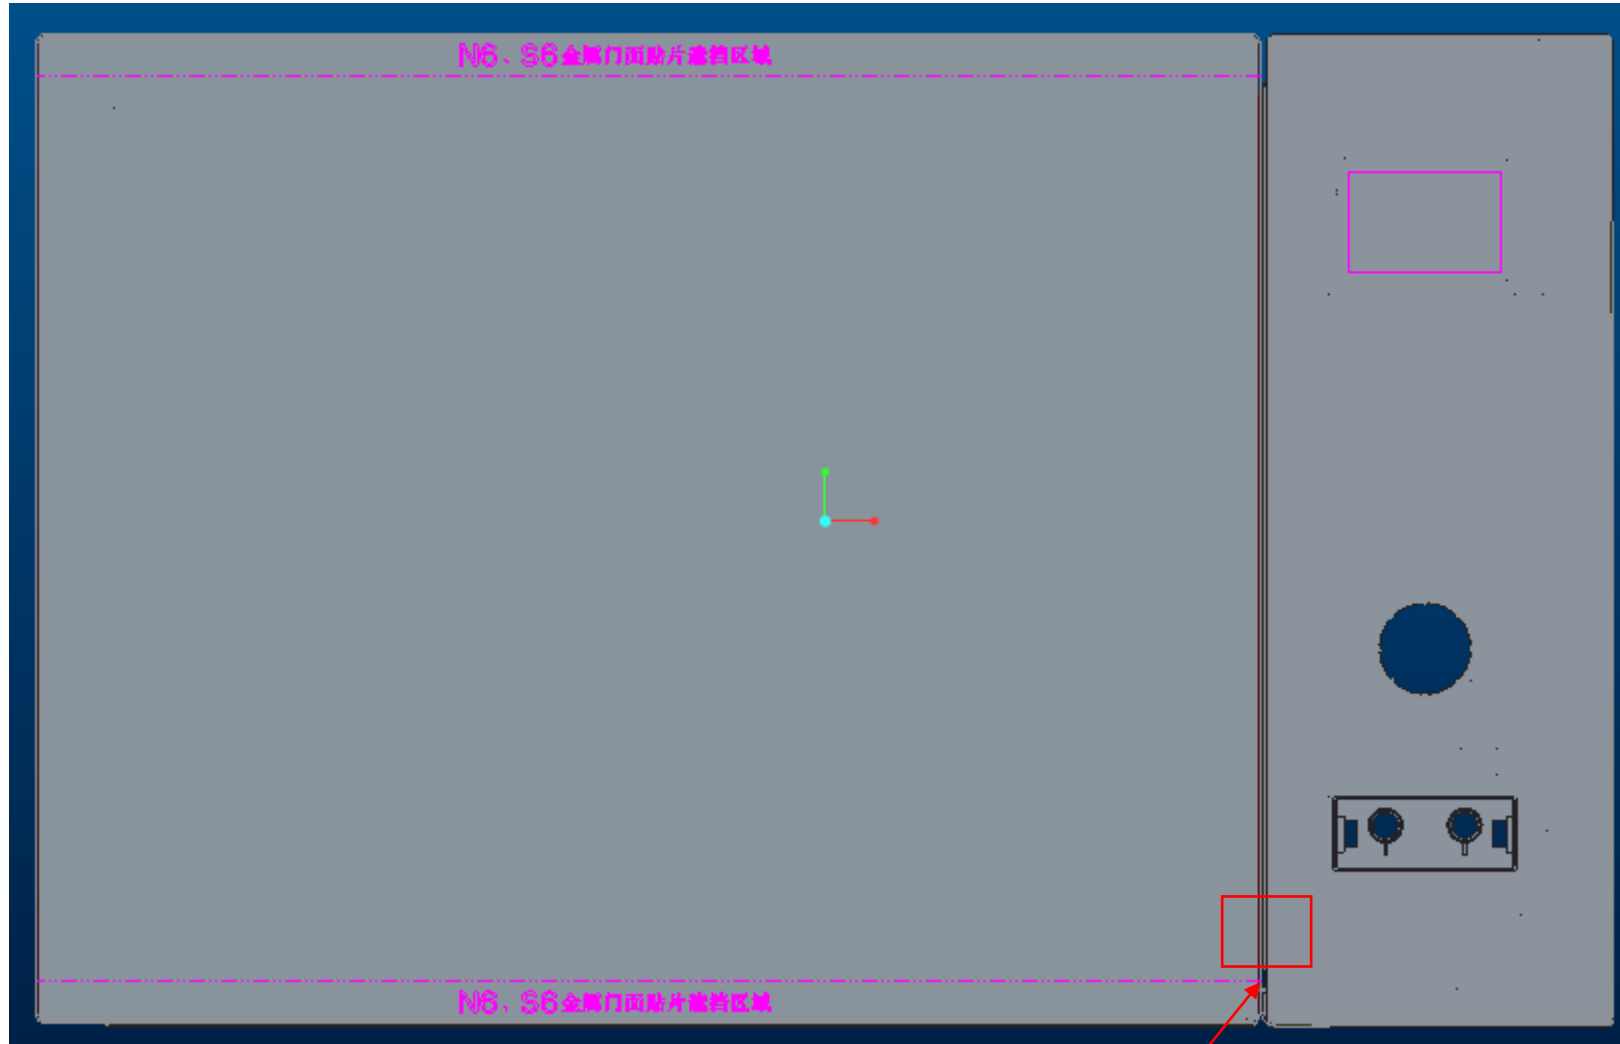
The front view

Changing area of control & door panel (one the side of the panel, nearly invisible when door is closed)

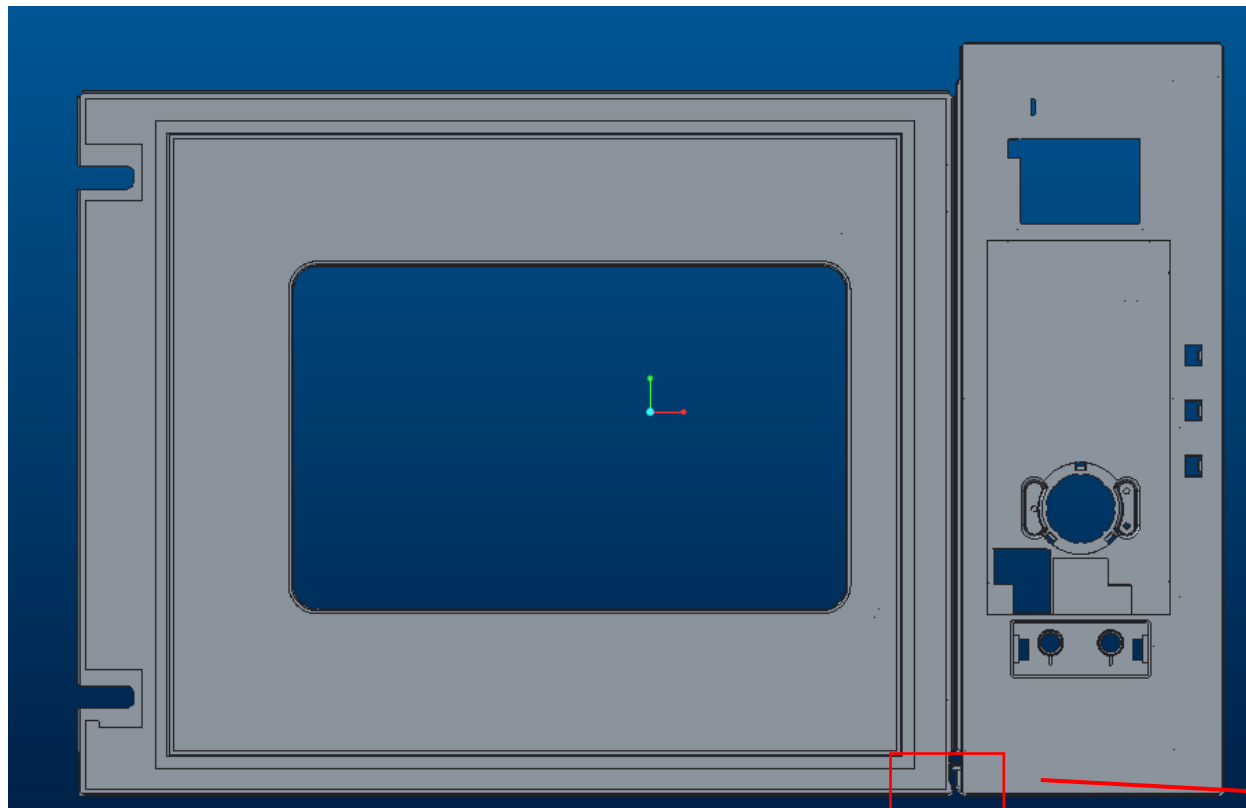
View without door & control panel glass (front)

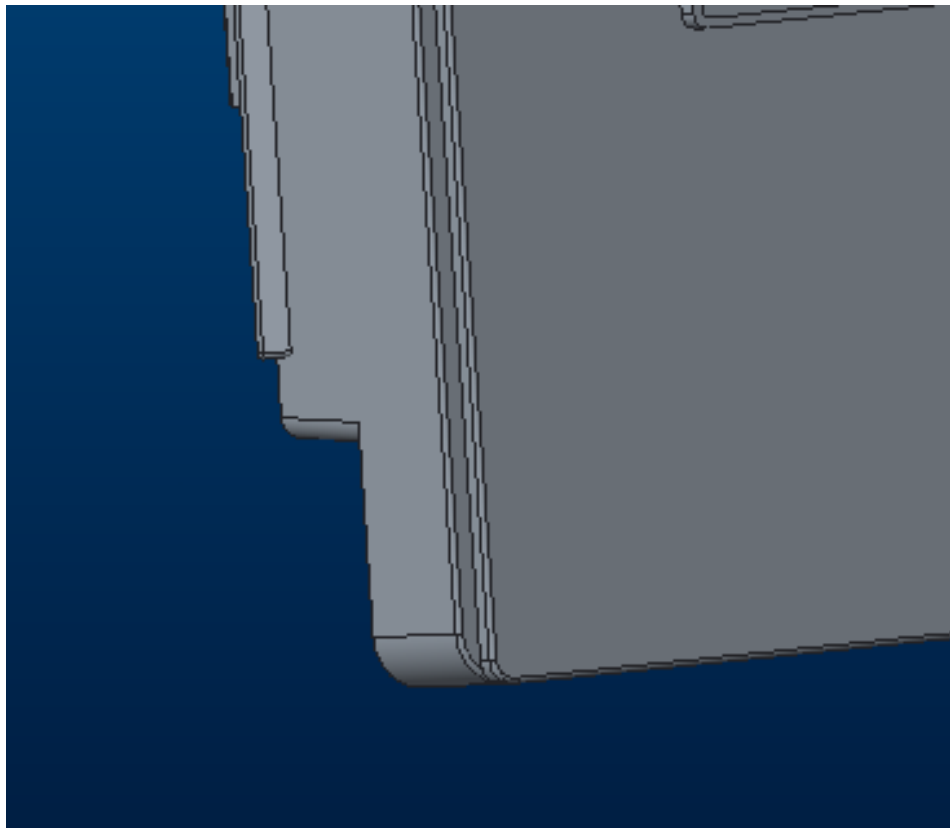
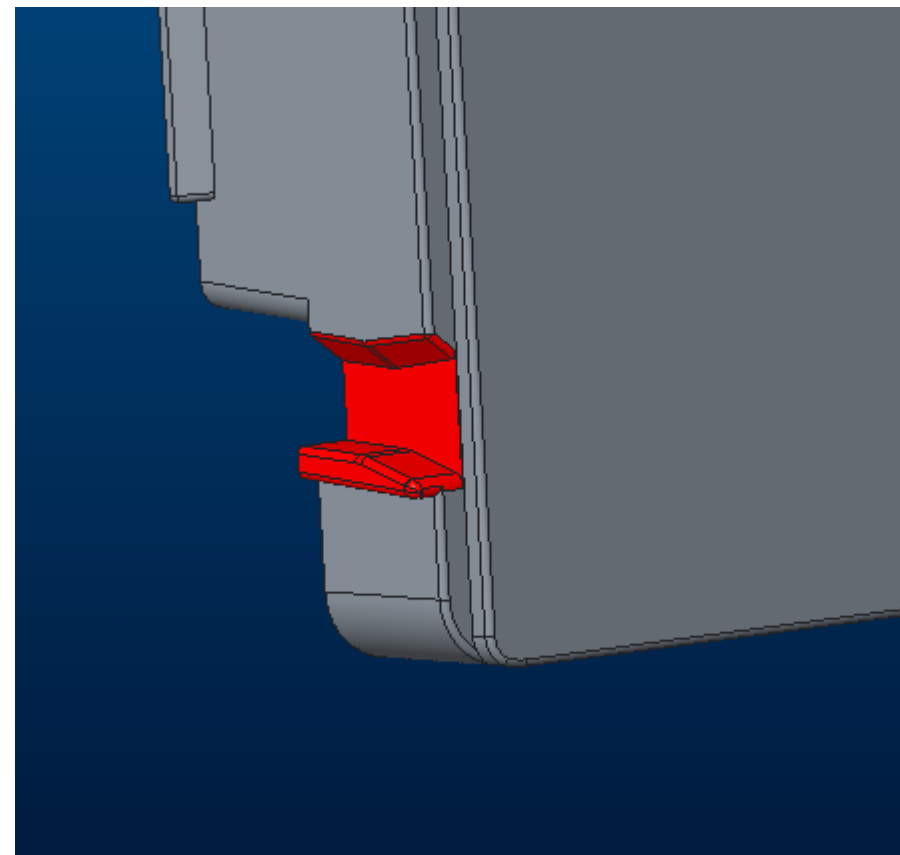
control panel

Add guide groove at the lower left corner

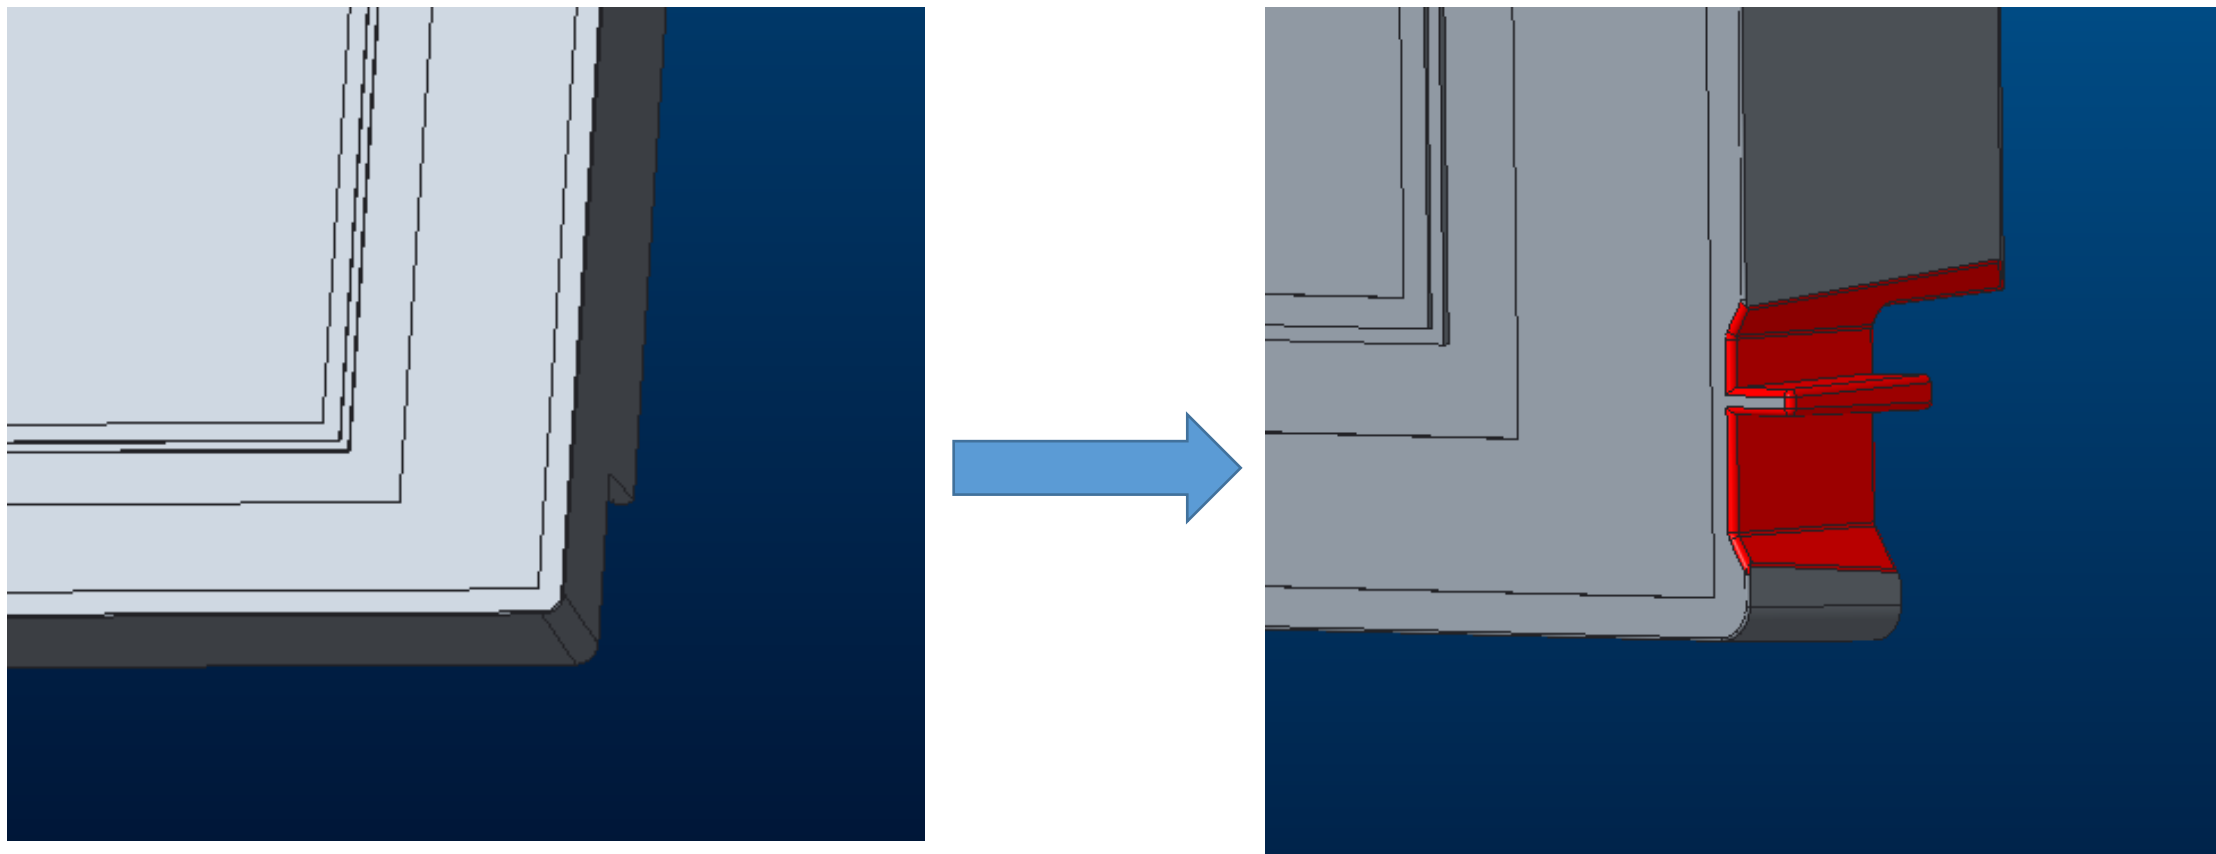
door panel

Add guide groove at the lower right corner

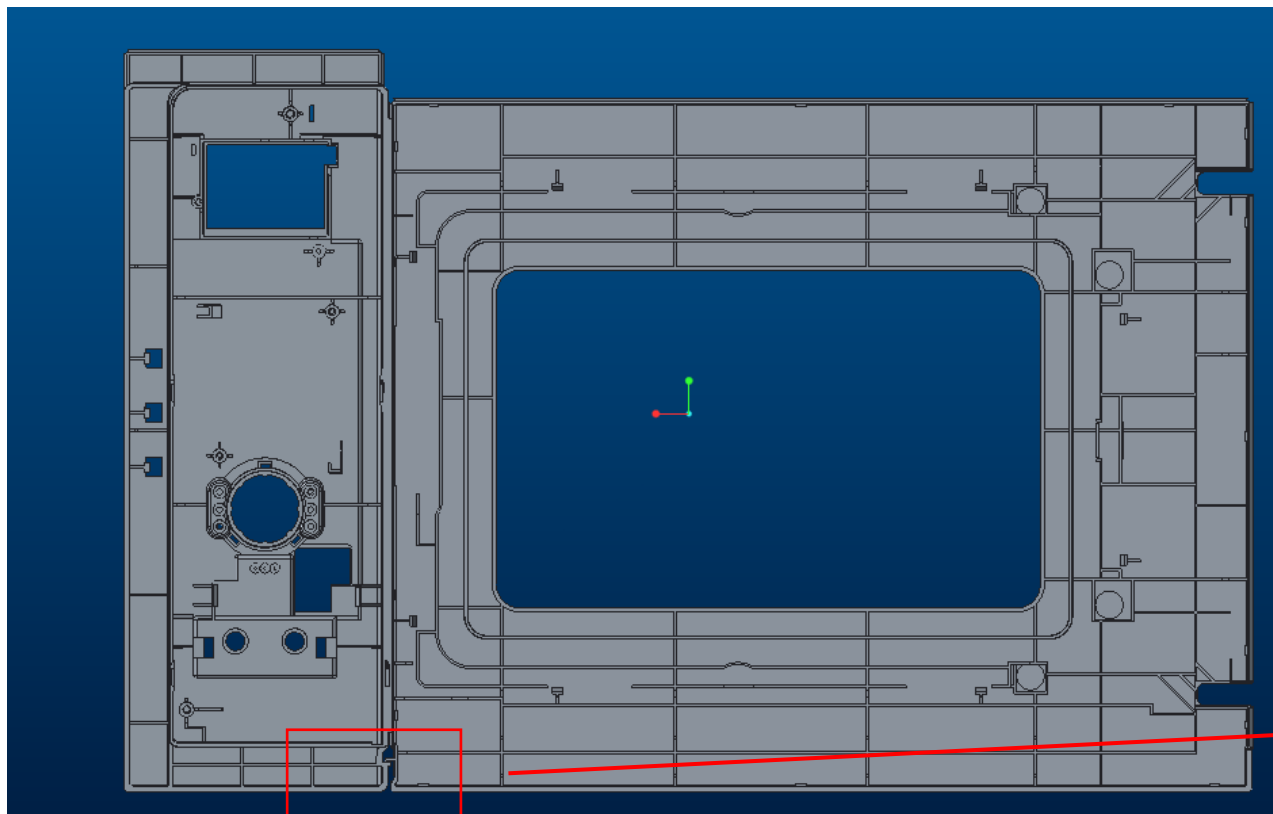
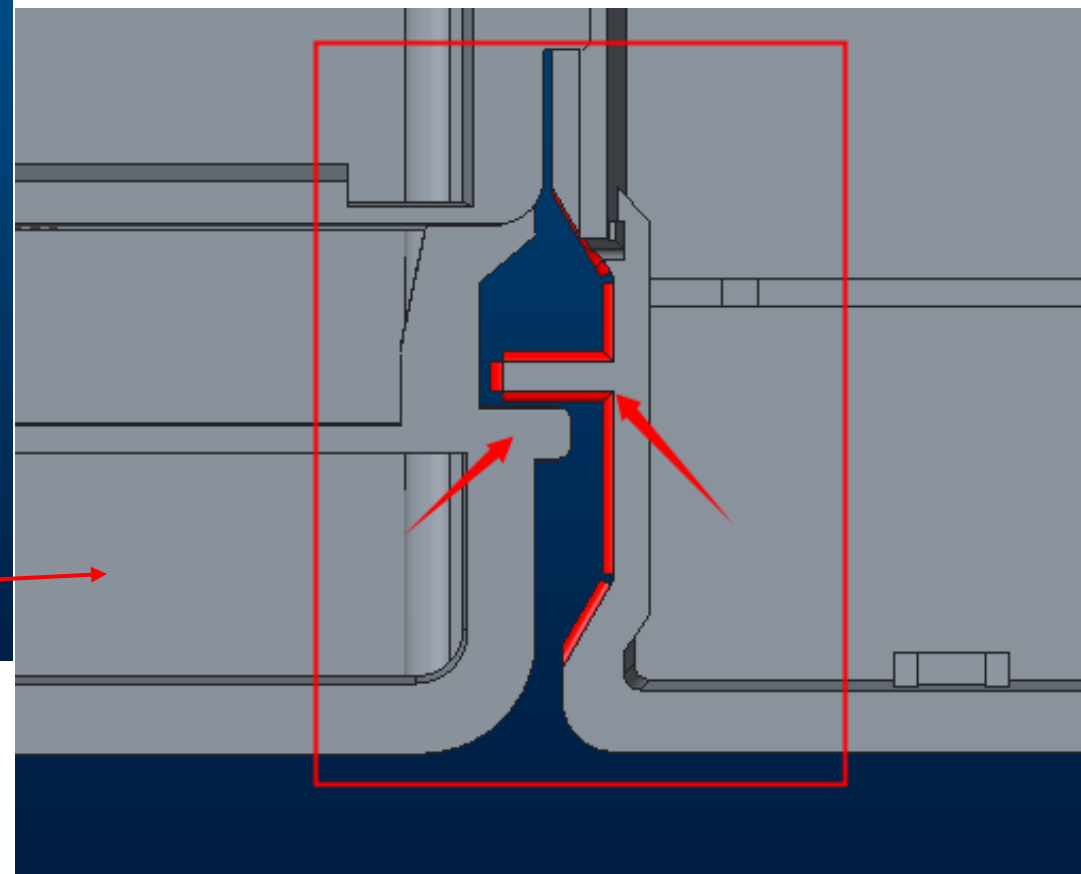
Control & Door panel assembly (backsight)
